# Manhole Inspection Summary

Manhole # S37GG1002MH

Insp Date: **1/10/07 3:32 PM**

**Location** Address: **3819 JUNIPER RD**

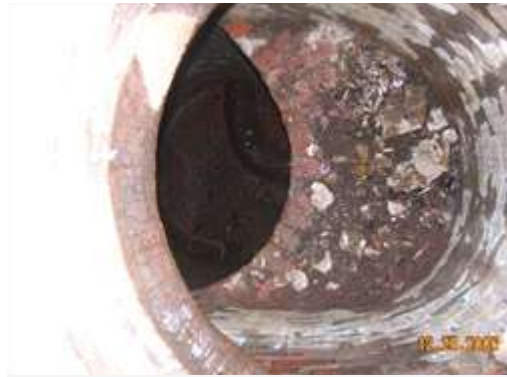
Top View

Infiltration: ☐ None ☐ Joint ☐ Cracks ☐ Mortar ☐ Roots ☒ **Wall**

**Bench** ☒ Exists Material: **Brick** ☐ Parged ☒ **Debris** (not Condition related)

**Surcharge** ☒ **Evidence Of Surcharge** Depth: **1** (ft.) ☐ Active Surcharge Present

Barrel infiltration. Evidence of surcharge - Bench debris.

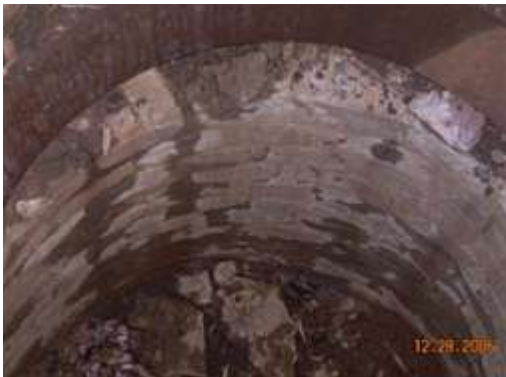
Defect

**Frame** Offset: **2** (in.) Condition: ☒ Sound ☐ Cracked ☐ Leaks

Condition: ☐ Sound ☐ Cracked ☐ Root Intrusion ☐ Loose Brick ☒ **Deteriorated**

Infiltration: ☐ None ☒ **Joint** ☐ Cracks ☐ Mortar ☐ Roots ☒ **Wall**

Frame offset. Adjustment deterioration and infiltration.

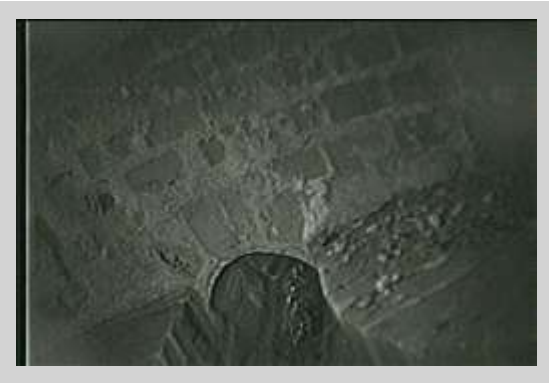
### 8 in. Circular Gravity Sewer Pipe Out @ 12 O'Clock

Pipe Material: **Clay** ☐ Pipe Lined

Invert Depth: **12.39** (ft.) Flow Characteristics: **Fast**

Infiltration: **None** Pipe Seal Cond: **Unknown**

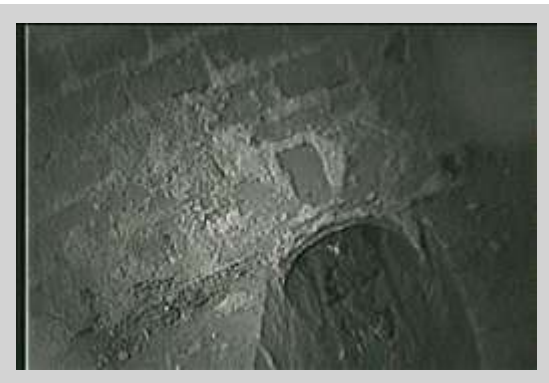
### 8 in. Circular Gravity Sewer Pipe In @ 3 O'Clock

Pipe Material: **Clay** ☐ Pipe Lined

Invert Depth: **12.07** (ft.) Flow Characteristics: **Fast**

Infiltration: **Evidence** Pipe Seal Cond: **Unknown**
